Non-Condensation Area in Need of Redevelopment Investigation

Town of Belvidere, Warren County, New Jersey

Report prepared on December 9, 2022

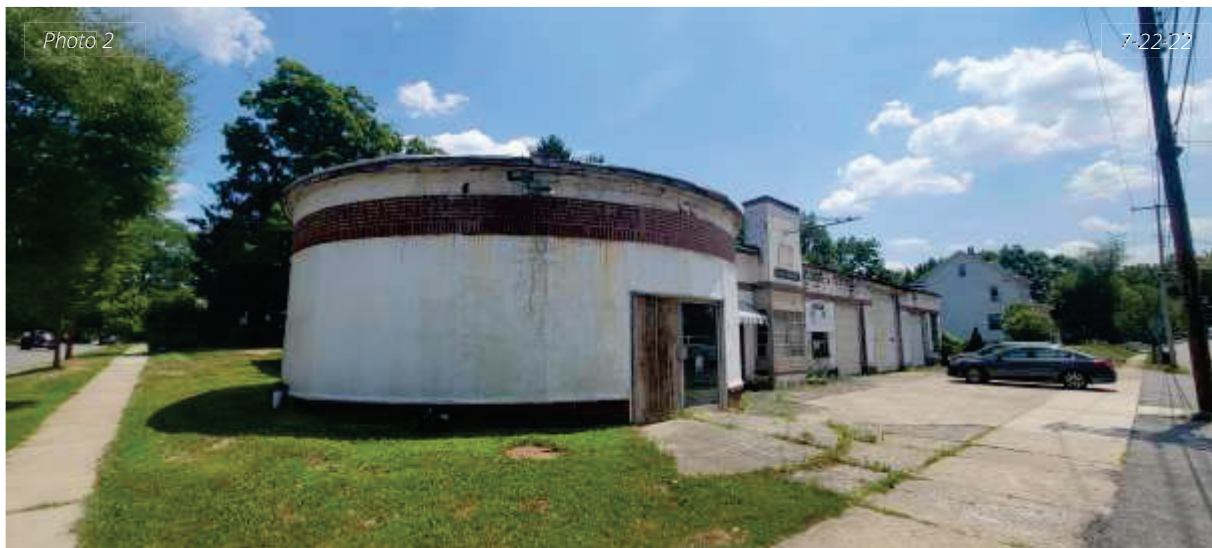
It appears that a portion of the building was demolished at some point as there is a freestanding building wall along the southerly property line, which has no horizontal support and could be at risk for collapse.

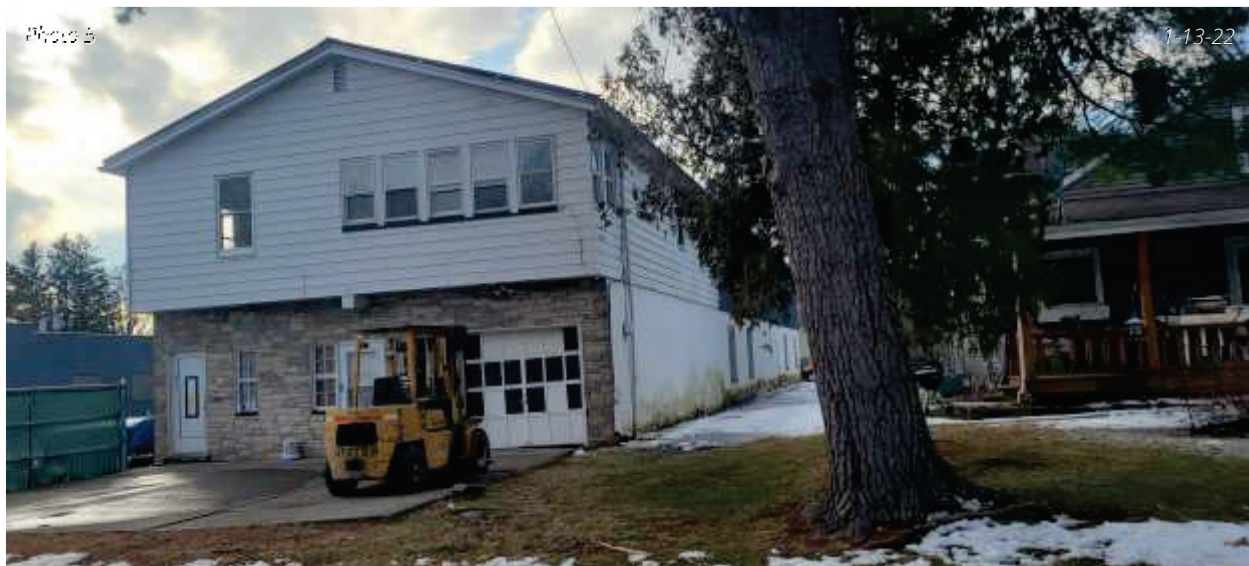
Photo 6

The building is utilized for storage related to the metal manufacturing business on Lot 3, and contains an apartment use on the second floor, which is not permitted in the LM District. There is a parking pad in the front of the building which is separated from the street by a grass strip. The garage door appears to be in poor condition. The property contains a fenced in area on the side and rear of the building which appears to be used for outdoor storage.

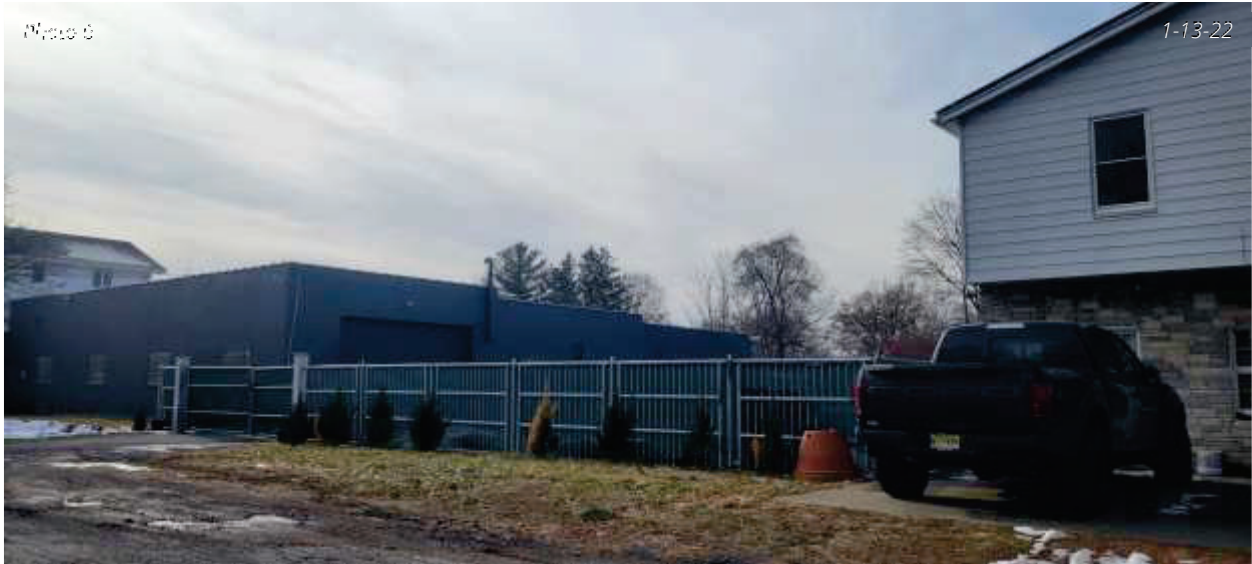
Photo 7

A second story addition to the rear of the building was constructed in 2019, according to building permit data. The building materials are not consistent on the various facades. The second story addition was constructed of sheet metal siding above the existing cinder block and stucco. The front façade contains stone veneer on the first floor and clapboard siding on the second story. Prior windows on the ground floor have been removed and replaced with bricks along the easterly façade. There is a heavy layer of mildew and algae growing on the side of the building and the stucco is missing or cracking in certain areas.

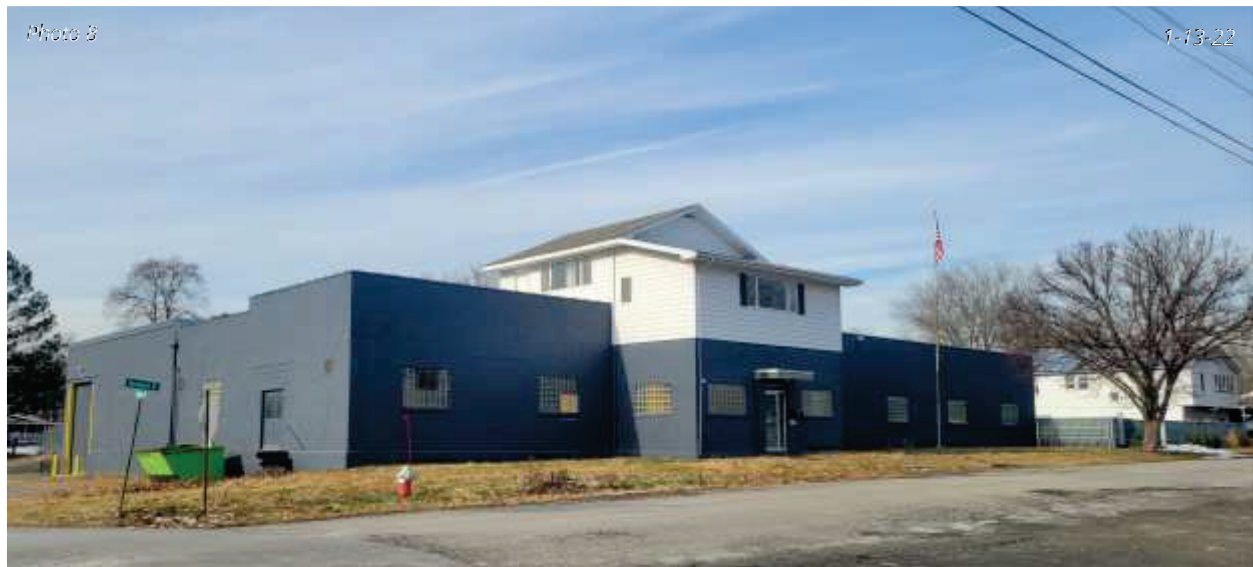
The building appears to consist of the original materials. There are cracks running through the exterior cinder block façade. The glass tile windows contain areas that are covered with plywood, presumably because the glass tiles are broken or missing. Other windows area also broken. There is an unenclosed dumpster in the front yard along Seventh Street.

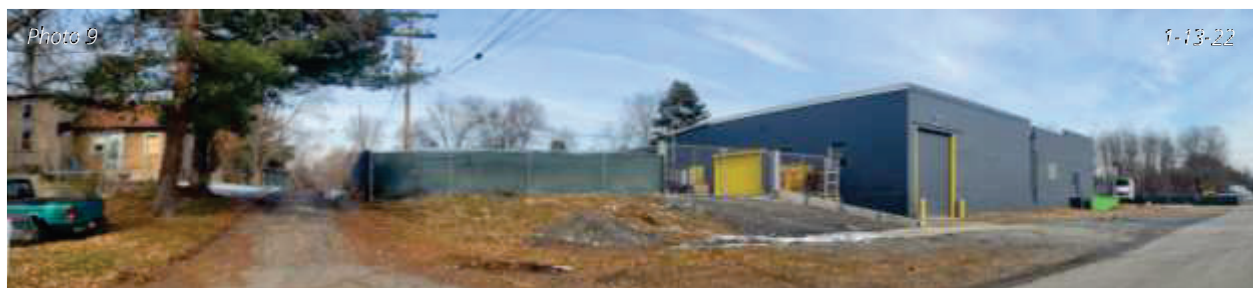
The rear of the property is enclosed by a 6-foot fence with green mesh screening. The rear yard appears to be used for outdoor storage. Lots 2 and 3, which are under common ownership, appear to be sharing the outdoor storage area as there is no fence separating the two properties.

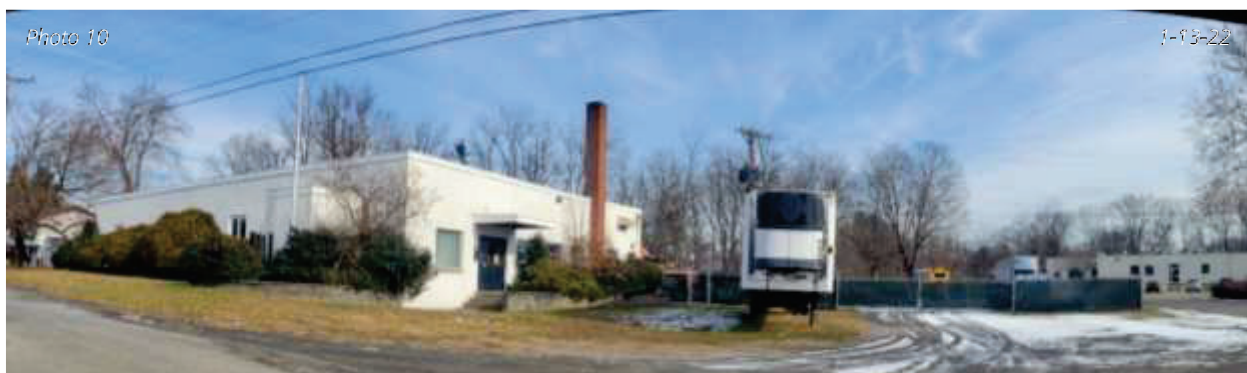
There is no formal off-street parking area on site and there are no walkways leading to the entrances. The stucco façade appears to be in fair condition with some minor staining and cracking. There are electrical wires hanging loose above the side entrance. There is also a note on the side door from a business owner seeking to rent the property. The note is very weathered indicating that it has likely been there for quite a while. This seems to indicate a lack of interest in upkeep or renting the property. It is unclear whether the building is occupied currently.

- **Block 45, Lot 5** – Lot 5 contains an industrial building over 65 years old and still consisting of the original building materials. There is no formal off-street parking area on site and there are no walkways leading to the entrances. There are also electrical wires hanging loose above the side entrance. The property contains over 80 percent lot coverage. Due to the obsolete layout and excessive land coverage, the properties present a detrimental impact to the welfare of the community. This is further evidenced by the zoning violations pending for the outdoor storage and the visibility of the outdoor storage area from adjacent residential properties.

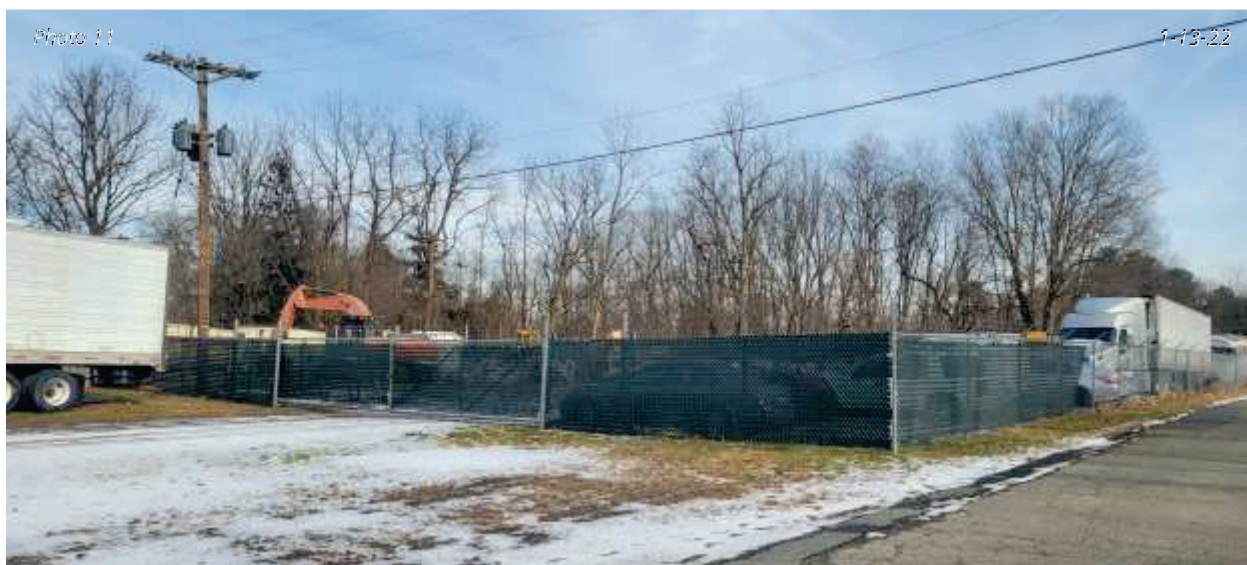
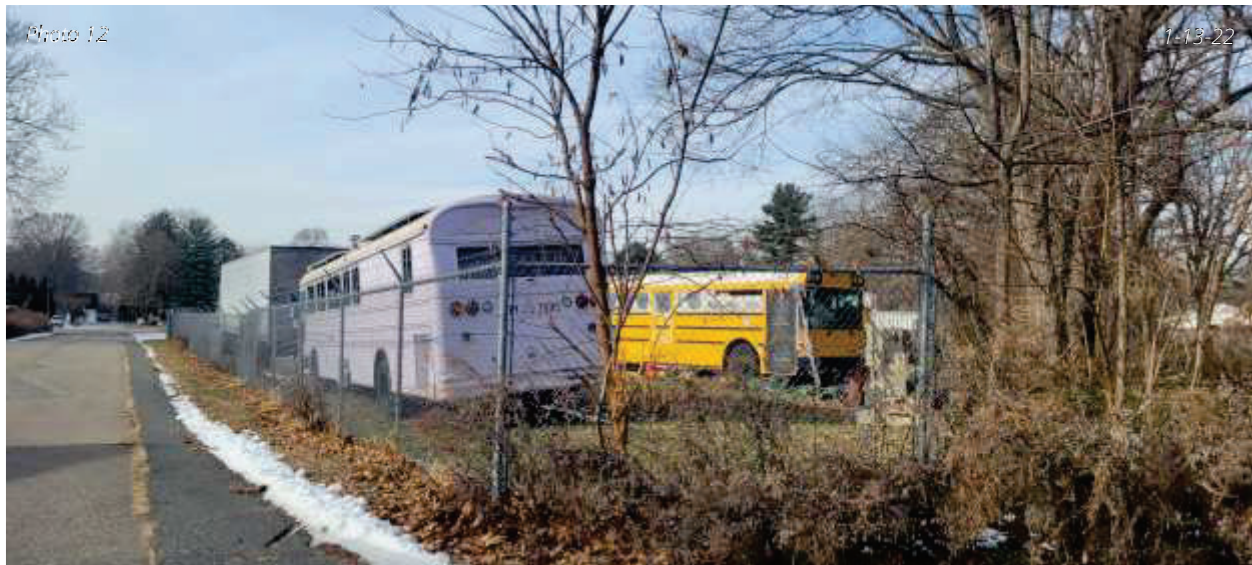
There is presently a truck trailer parked in the front yard and the rear yard is enclosed by a 6-foot chain link fence with barbed wire and green mesh screening covering portions of the fence visible from Hardwick Street. There is no screening of the storage area from the abutting residential properties to the rear. The rear yard is being used for outdoor storage of vehicles, tractor trailers, buses, construction machinery, and various stockpiles of materials. The property was issued a zoning violation in 2019 for outdoor storage of excess debris and items not related to business.

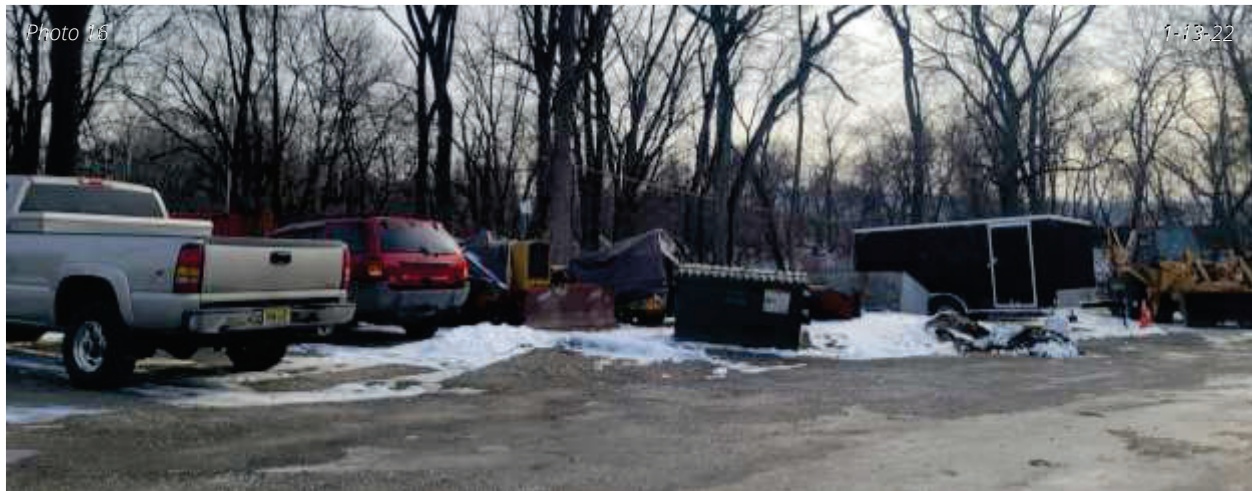
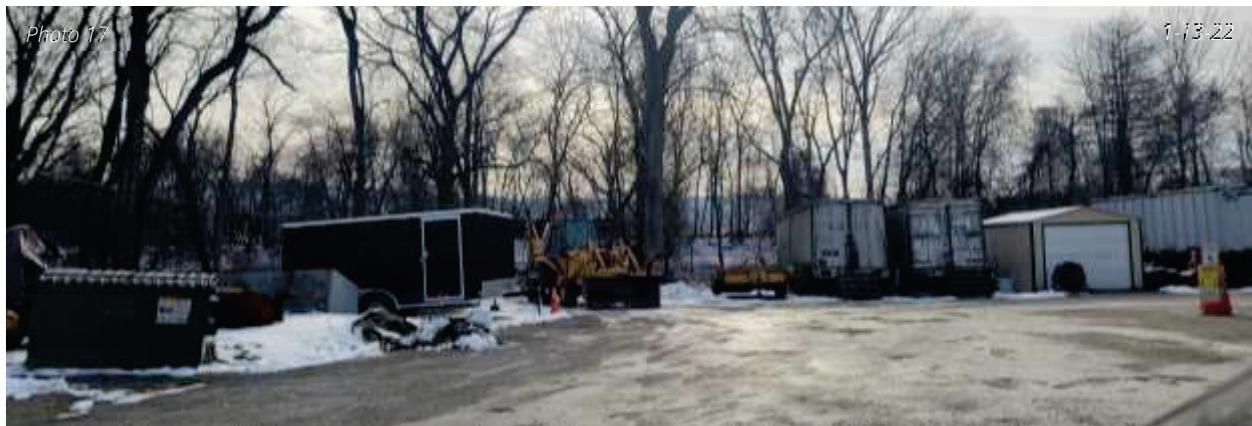
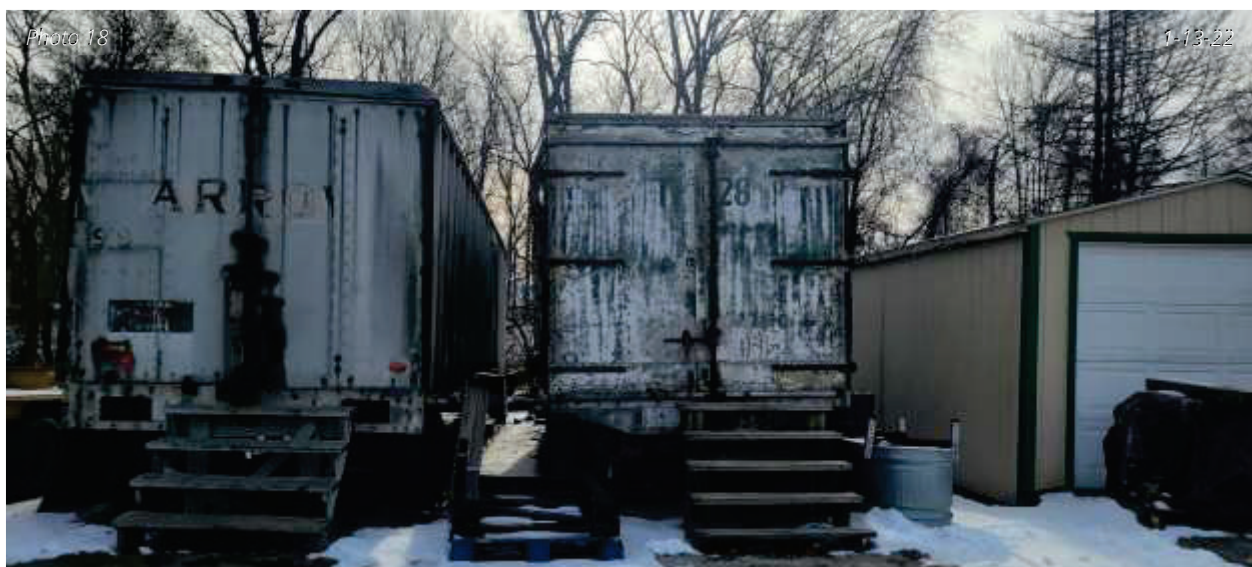
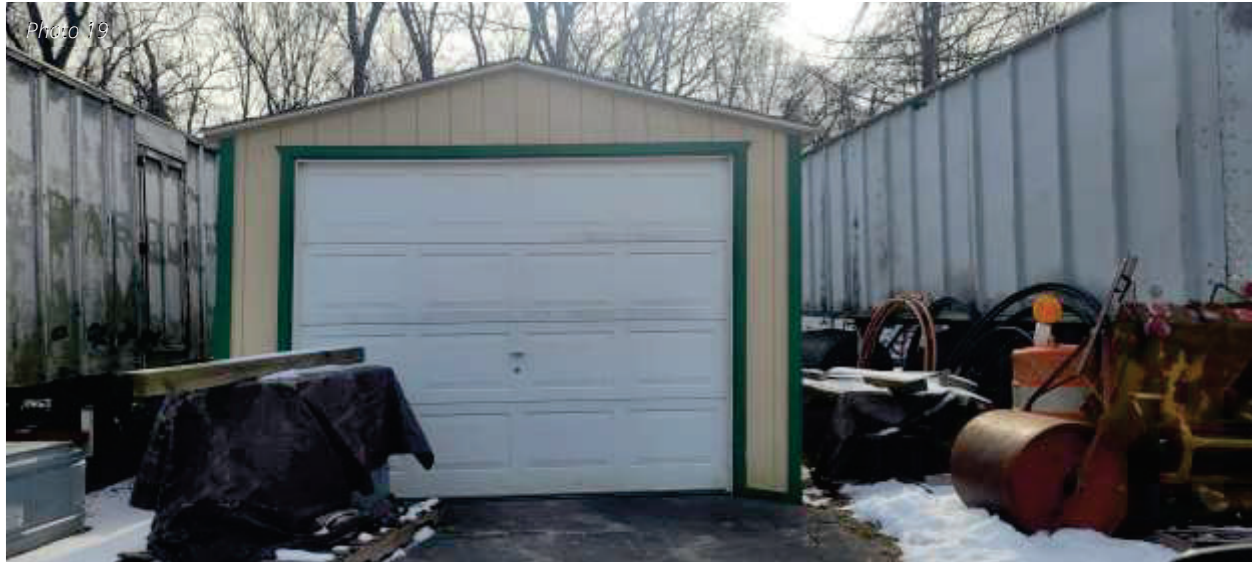
In the rear, there is an unenclosed outdoor storage area containing truck trailers, various construction vehicles, equipment, and other materials and debris. Photos 15, 16, 17 and 18 show the unenclosed and unscreened outdoor storage area along the perimeter of the parking area.

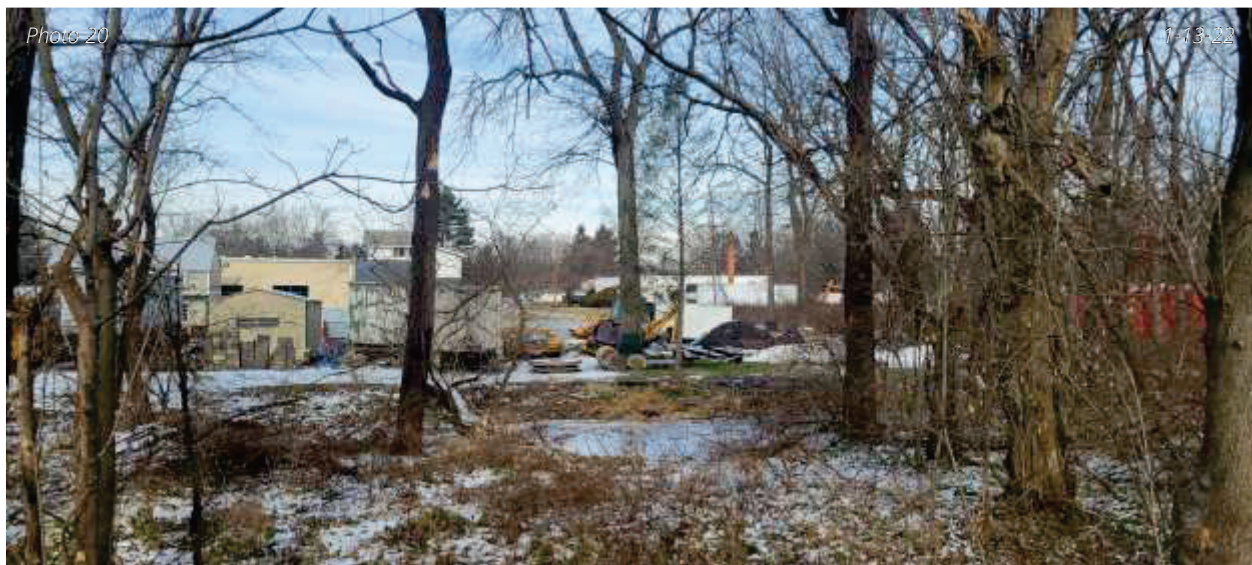
Photo 19 below shows the rear of the property as viewed from the Mansfield Street extension that crosses the Pophandusing Brook and runs along the municipal boundary line in White Township. Vehicles, equipment and materials can be seen stored up to the banks of the brook.

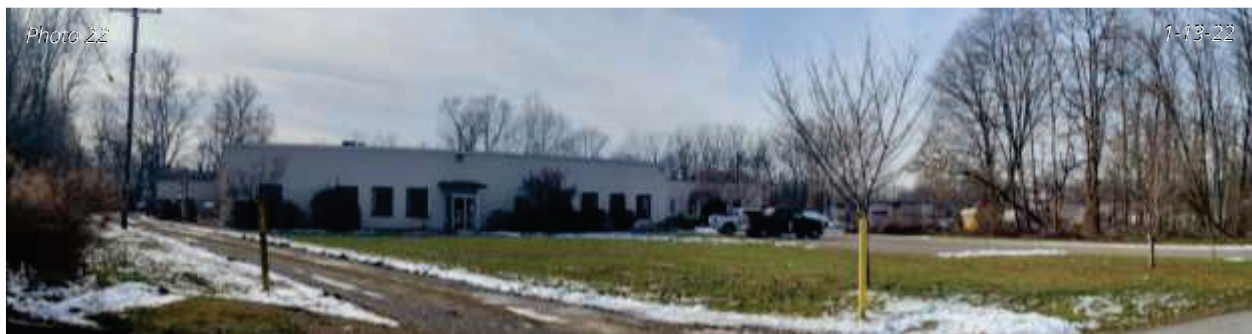
Lot 2 in Block 46 is a 2.97-acre parcel located along the south side of Seventh Street. The property has a street address of 560 Independence Street despite having no frontage along the Independence Street right-of-way. The property is developed with a 29,200-square foot industrial building owned by LM Holdings, LLC. The property is accessed via the private driveway through Lots 7 and 8 in Block 45, which act as an extension of Seventh Street between Hardwick Street and Independence Street. The building was constructed prior to 1970 and underwent renovations in 1997. The cinder block façade appears to be in fair condition with minor cracking seen in some areas.

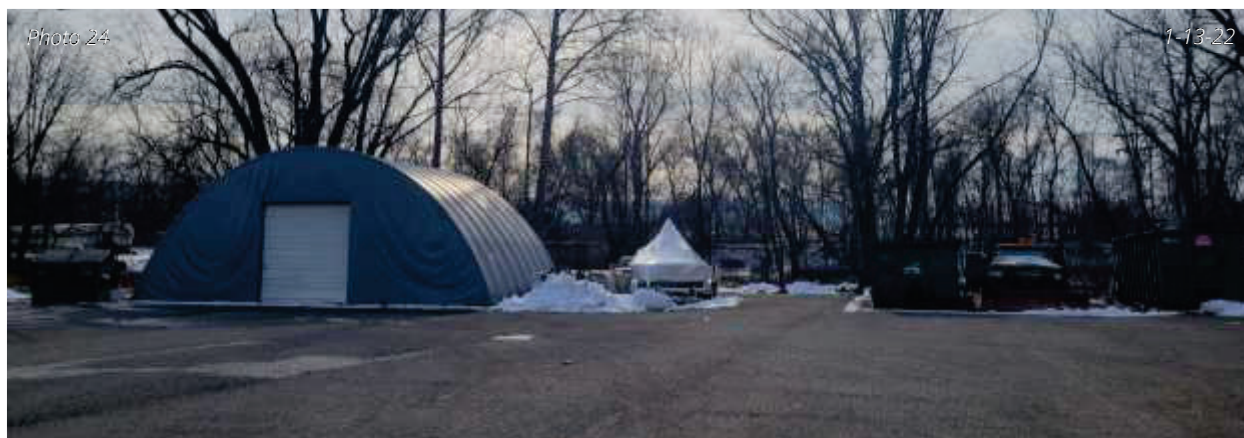
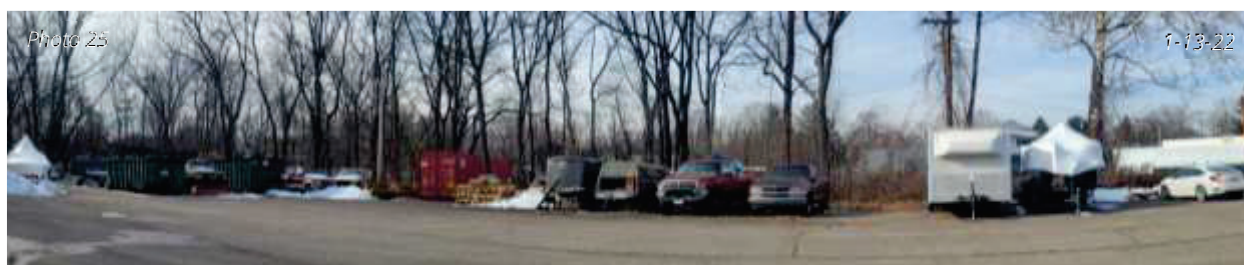
The parking lot in the western portion of the site is used for vehicle parking along the building and outdoor storage of various equipment and materials along the southern and western edges of the

paved area, which may not be related to the business. There is a temporary accessory storage building, covered boats on trailers, several unenclosed dumpsters, vehicles that appear to be non-operational, storage containers, and piles of materials and debris.

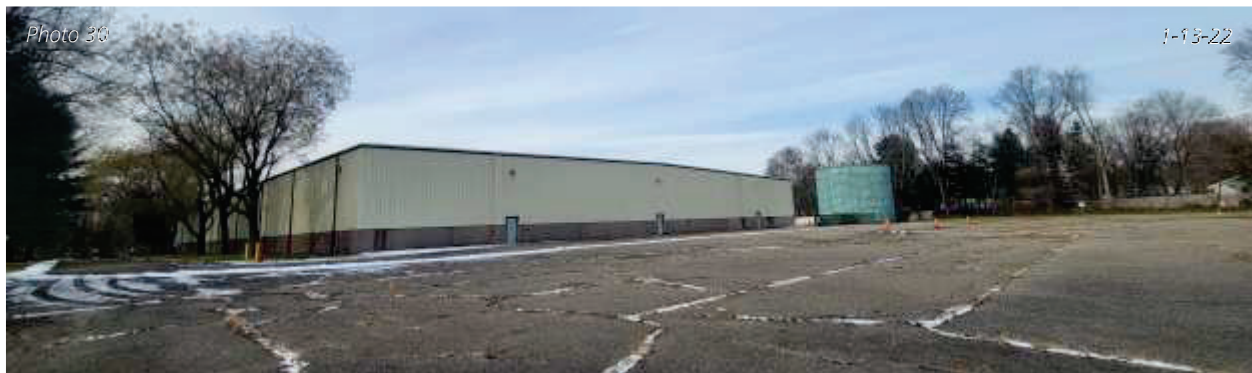
The wooden roof decking is in need of replacement. Metal paneling has been installed along the top of the walls to help prolong the life of the roof, but it's only a temporary fix according to the owner.

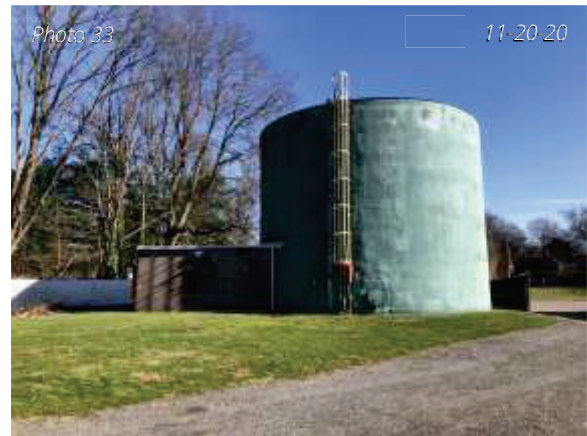
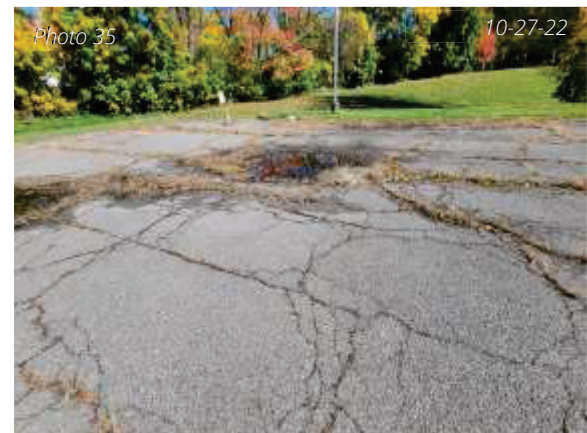
- The exterior metal wall panels are rusty and corroded.
- The chain link fencing around the perimeter is old and rusty, and falling down in places. The fence appears to be only 4 or 5 feet tall with barbed wire on top, which could be a safety concern.

- The water tank in the rear is nearing the end of its life. The exterior insulation has holes and bulges. The interior tank liner needs replacement, according to the owner during the November 2020 visit. During the October 2022 visit, the owner advised that the exterior was patched, and a new liner installed, yet still deteriorating and in need of additional work.

- Exterior building connections between the old and newer portions of the building are in poor condition.
- There are concrete pylons in the rear of the building that were left as remnants of past equipment that have been removed.

- Interior signs of decay:
 - Peeling paint
 - Signs of leaking roof (past or present)
 - Roof drains within the ceiling are failing
 - Concrete floor sealant missing in areas

- Antiquated doors and windows (old heavy manual sliding doors)
 - Interior rooms or offices are small with no natural light, no exterior windows or skylights

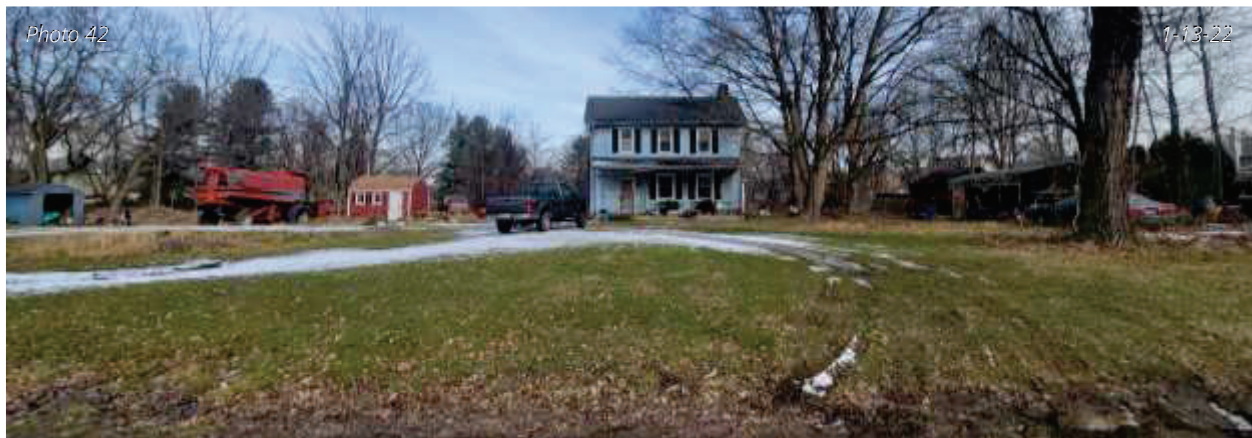
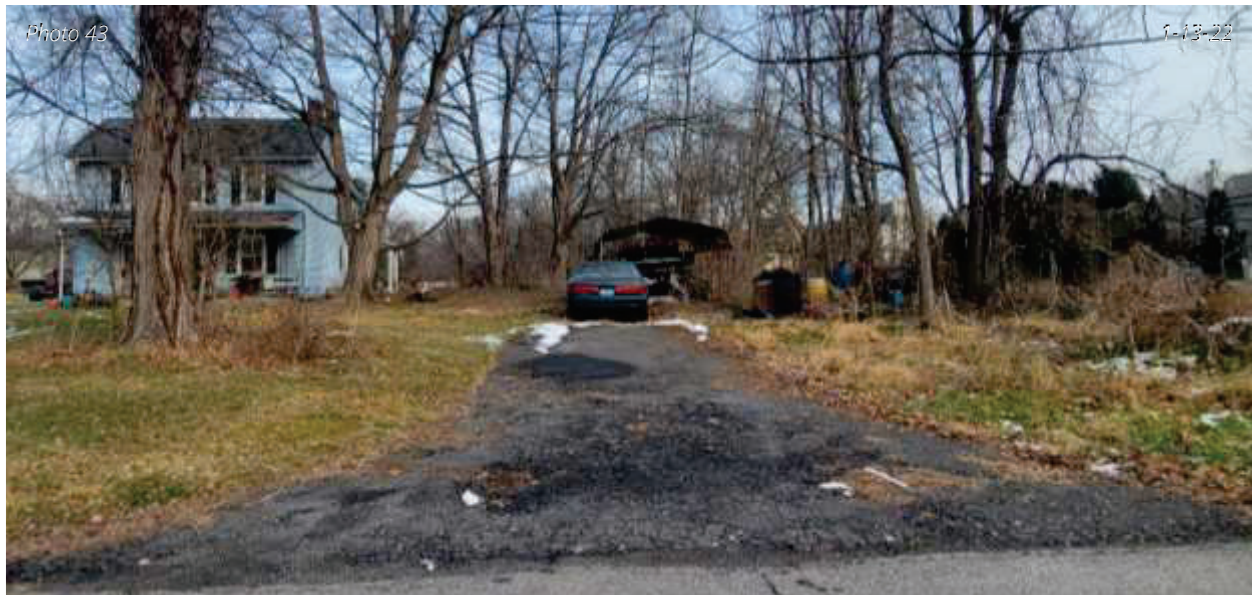
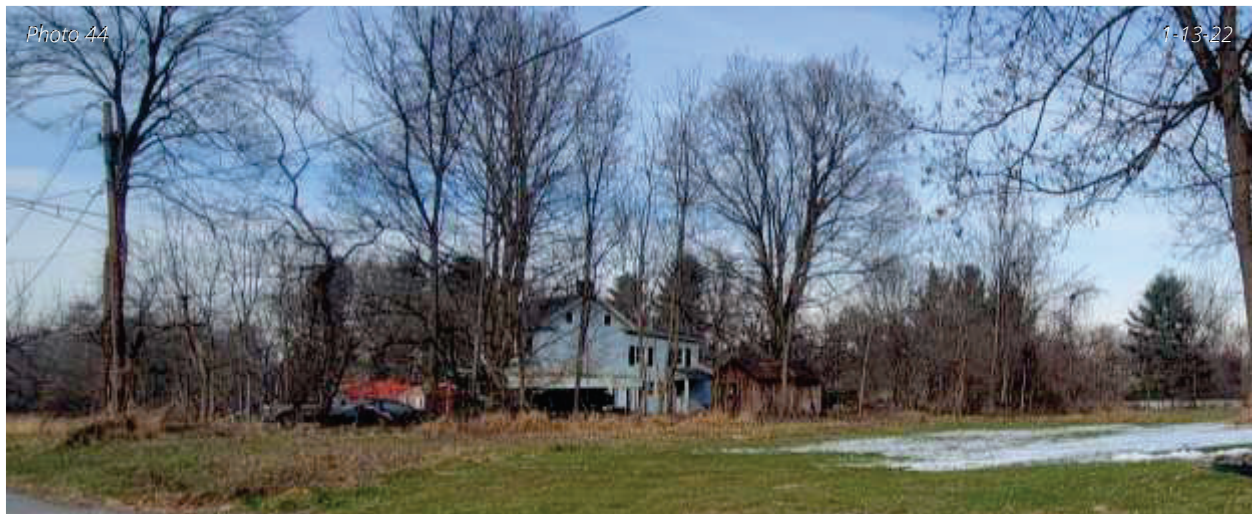
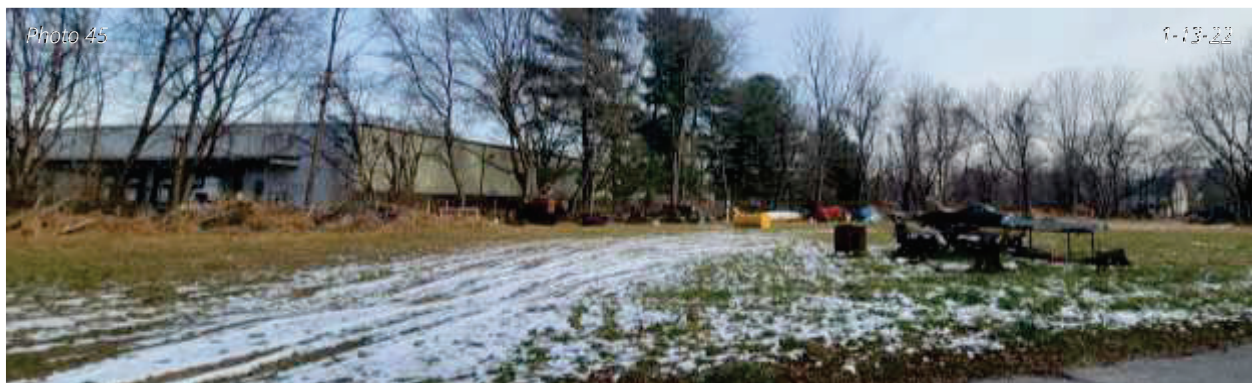
Lot 8 in Block 48 is a 2.76-acre parcel located at the corner of Independence Street and Knowlton Street. The property is developed with a single-family dwelling owned by Gene Farber. The two-story colonial home was originally constructed in 1860 according to tax records and contains 1,836 square feet. The property tax card lists the property in fair condition. The gutter on the front porch roof was hanging off and the front door appears to be broken. There is a gravel driveway which contains two vehicles that appear to be in disrepair. It appears that the resident prefers to park on the front lawn instead of the driveway as there was a truck parked in the grass near the front porch with numerous sets of tire tracks running through the grass to the road. There are numerous accessory structures on the property, some of which are dilapidated and in danger of collapsing.

The property is taxed as a single-family residential use and is not farm assessed, despite the property being used to store farm equipment. There is a large combine, several tractors, old pickup trucks and other vehicles, and various other agricultural equipment and attachments stored around the perimeter of the property. It is unknown whether any of the equipment is in working order. There are numerous plastic barrels, buckets, and other debris scattered around the property that could present a safety hazard. The outdoor storage of various equipment and other items not typically found on a residential lot give the overall appearance akin to a junk yard. In addition, the dwelling is a nonconforming use as residential uses are not permitted in the LM District.

- **Block 48, Lot 8** - This residential property is being used for excessive outdoor storage of various farm and nonfarm vehicles, equipment and debris. Some of the accessory structures are in dilapidated condition. The overall appearance of the property contributes to dilapidation and blight. The property presents a detrimental impact to the welfare of the community.

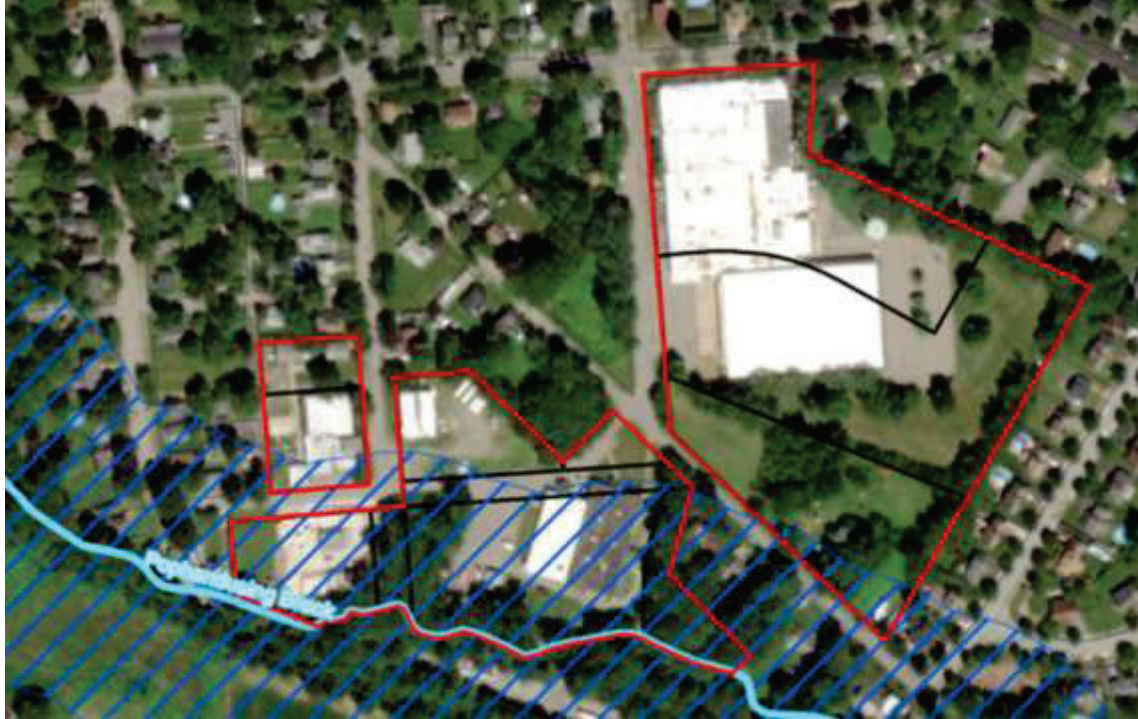
Map 14: NJDEP Category-1 Stream with 300-foot riparian buffer shown in blue hatching

The study area abuts the Pophandusing Brook, which is designated by the NJDEP as a Category 1 trout producing stream. NJDEP regulates a 300-foot-wide riparian buffer along Category 1 streams. As shown on Map X below, the 300-foot riparian buffer encumbers Lots 2, 3, 4 and 5 in Block 46, as well as portions of Lot 3 in Block 42 and Lots 5 and 8 in Block 45.

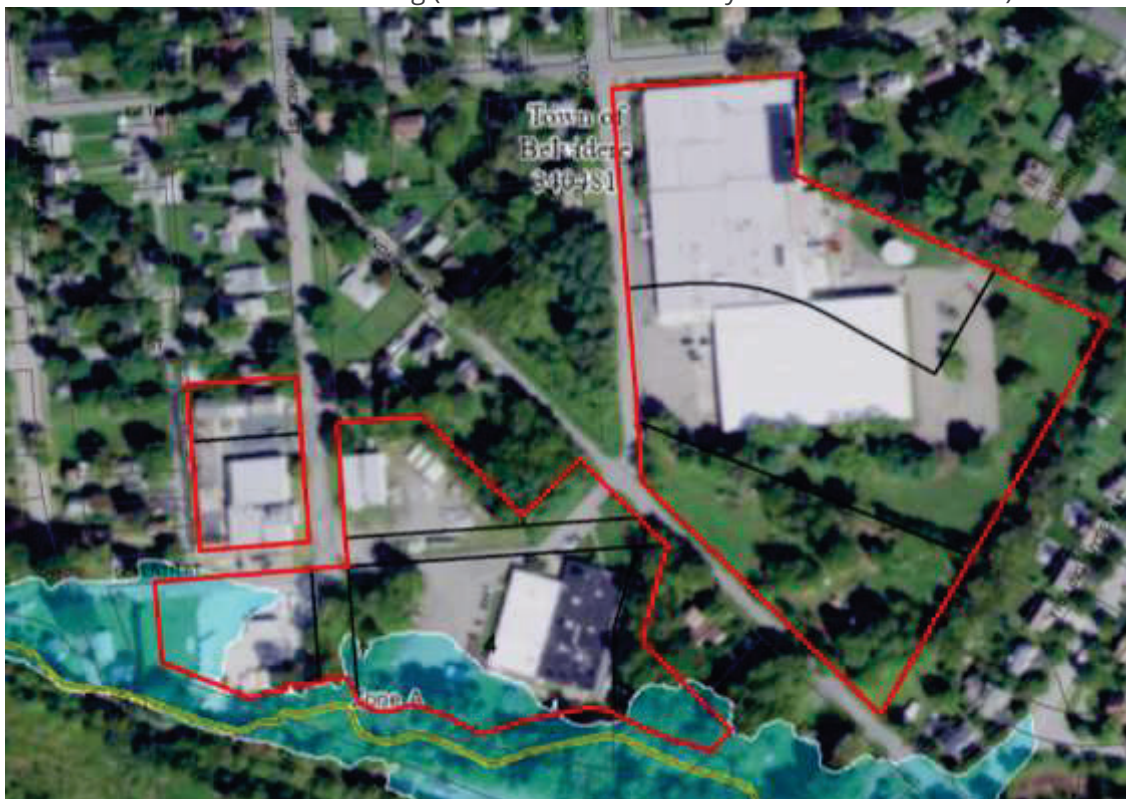
Map 15: FEMA Flood Insurance Rate Map, A-Zone shown in blue (Map #34041C0204E, effective September 29, 2011)

Portions of the study area are also located within a flood hazard area. FEMA Flood Insurance Rate mapping shows portions of Lots 2, 3, 4, and 5 in Block 46 being encumbered by the A Zone, which has a 1% annual chance of flooding (also known as the 100-year flood hazard area).

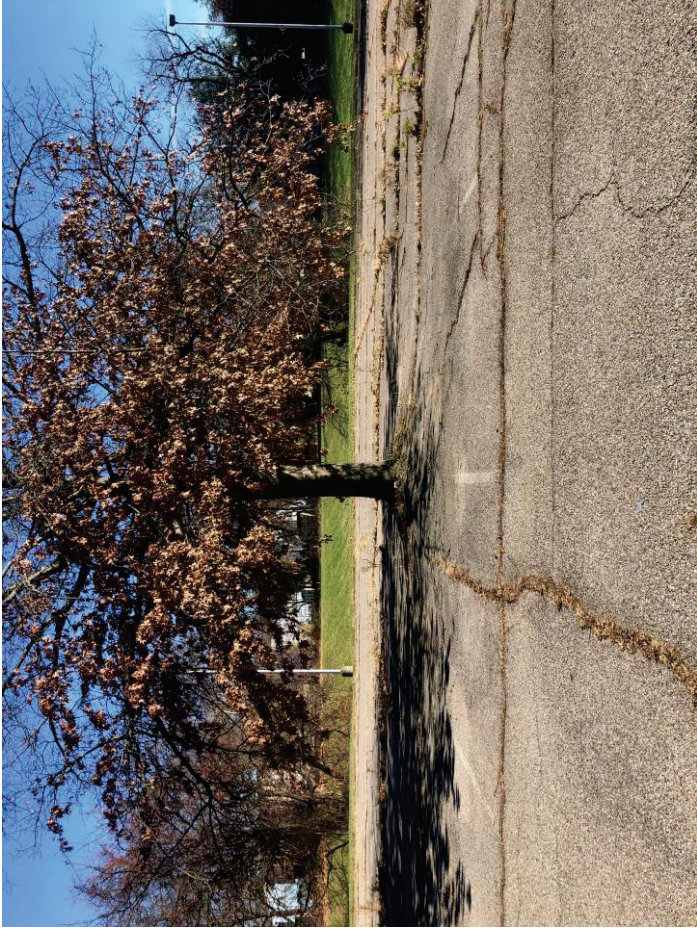
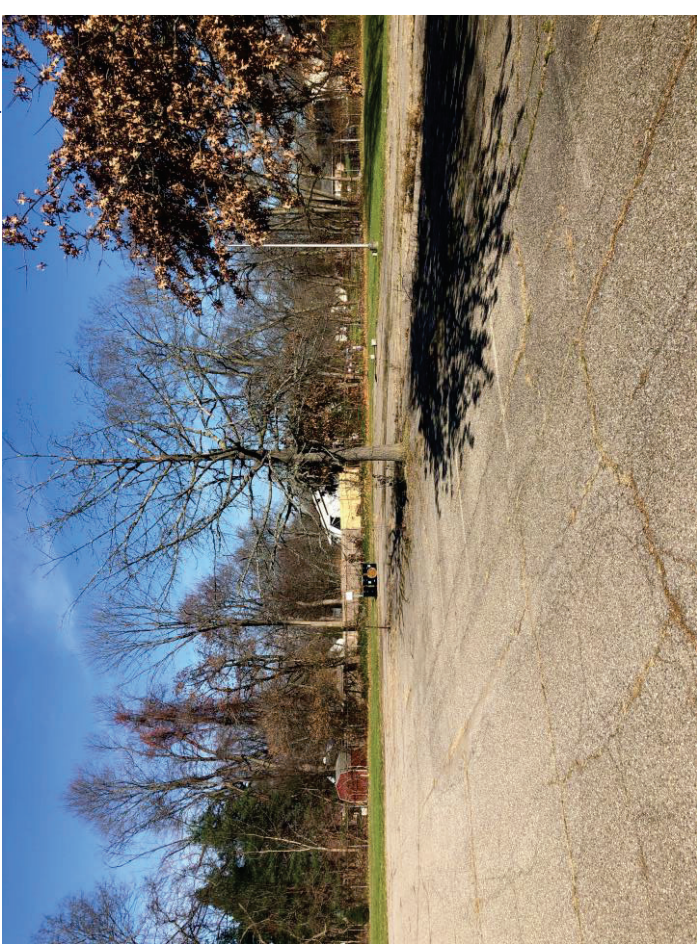
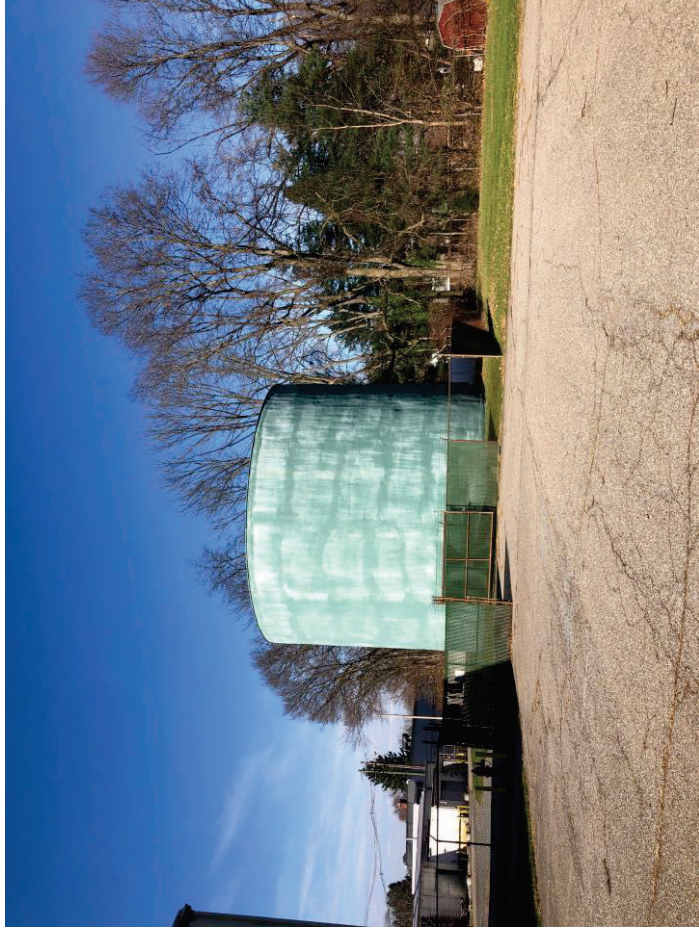
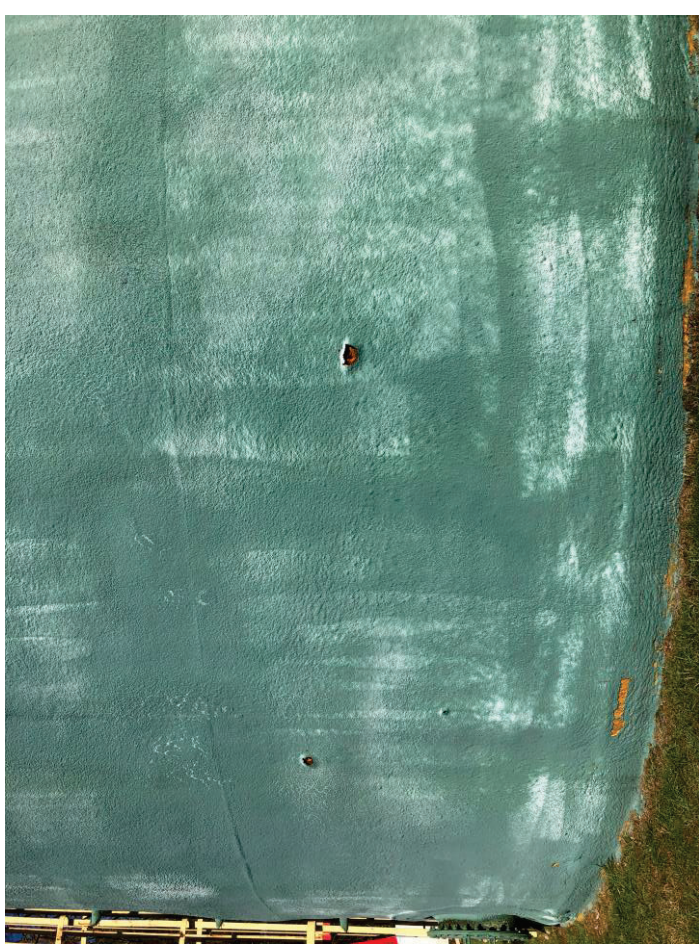
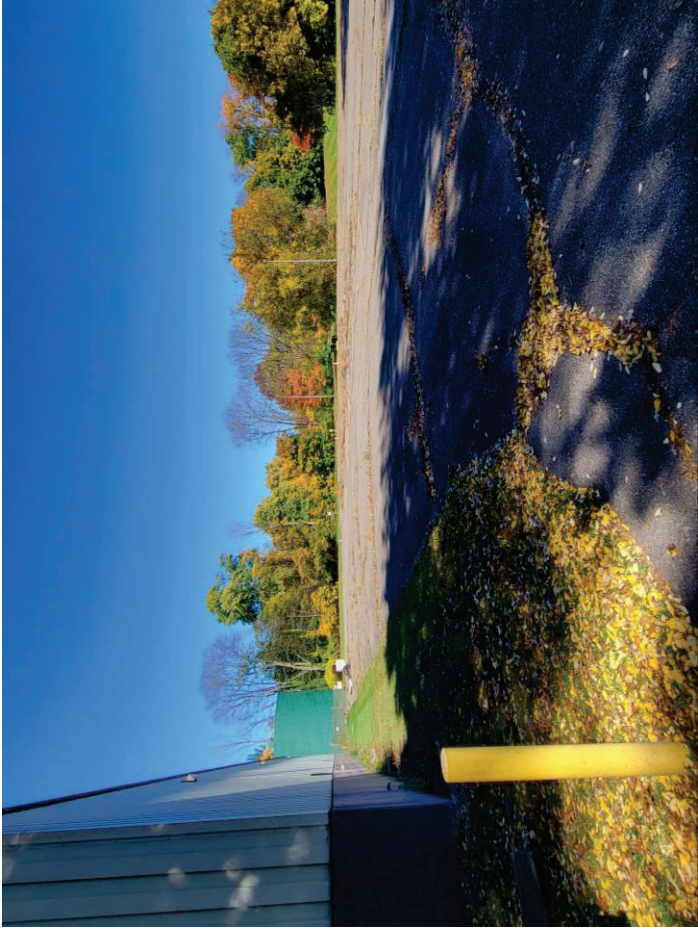
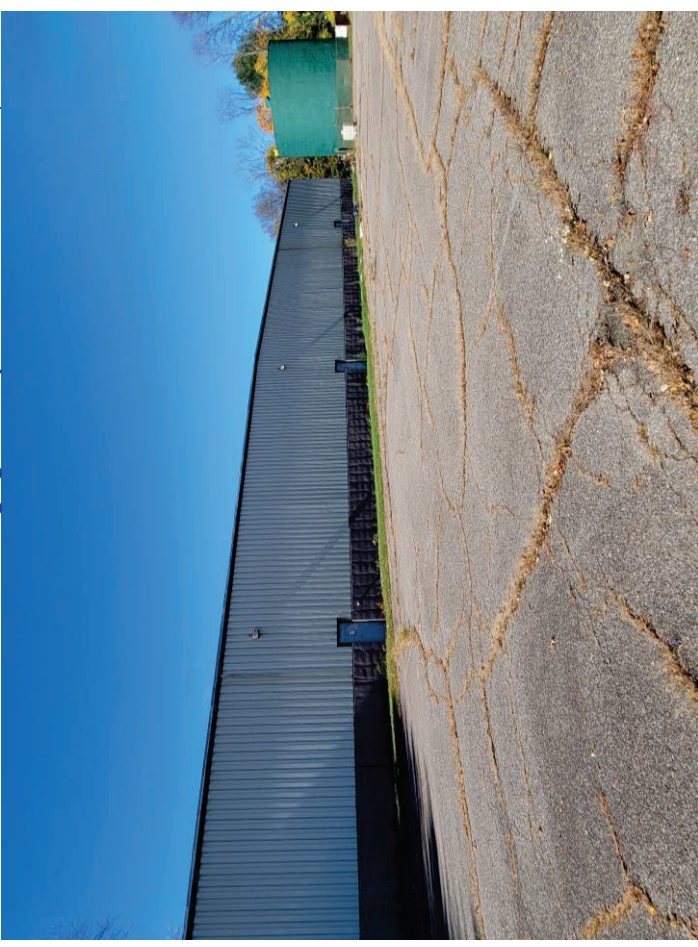
Block 47, Lot 10
& Block 48, Lot 7

- **Block 47, Lot 10 & Block 48, Lot 7** - The property contains the former Graham Packaging industrial building. Although the building is currently occupied, the property still has several areas of concern that need to be addressed. Most significantly, the property has an insufficient and nonfunctioning stormwater drainage system, which is causing flooding issues within the building during rain events. Inside the building, the roof drain system is failing and in need of replacement, the epoxy flooring is in poor condition and needs to be replaced, half of the loading dock levels are inoperable and need to be replaced, and the electrical system needs to be upgraded, among other items. By reason of dilapidation, obsolescence, faulty arrangement or design, and obsolete layout, the property presents a detrimental impact to the welfare of the community.

The former operations at the site also caused groundwater contamination, which have a potential to impact the health and safety of nearby residents. Without continued remediation of the property, the site poses a deleterious land use to the welfare of the adjacent residential and non-residential neighbors.
